HOME HOUSE - Materials Analysis

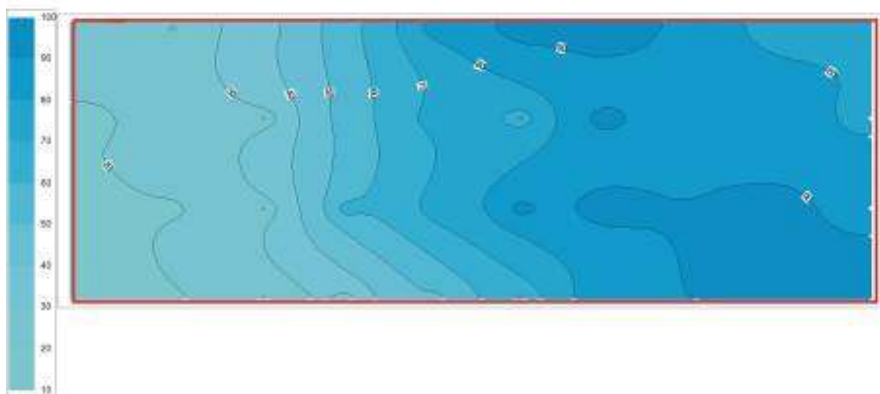
Paint was lifting on the inside of the south wall of Home House Dairy. Moisture mapping of the wall revealed localised elevated moisture levels on the upper parts at one end of the wall.

Inspection outside showed a lead lined gully running along the top edge of this wall. It was recommended that the gully be inspected for leaks, as this was considered a likely source of the ingress of water.

Moisture map of south wall
2.7 m wide by 0.9 m high

Watching brief instigated for moisture in the wall. Paint surface restored.
