THE MYNDE – Plasterwork Conservation

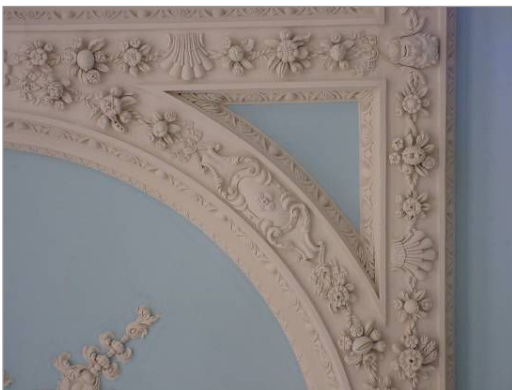
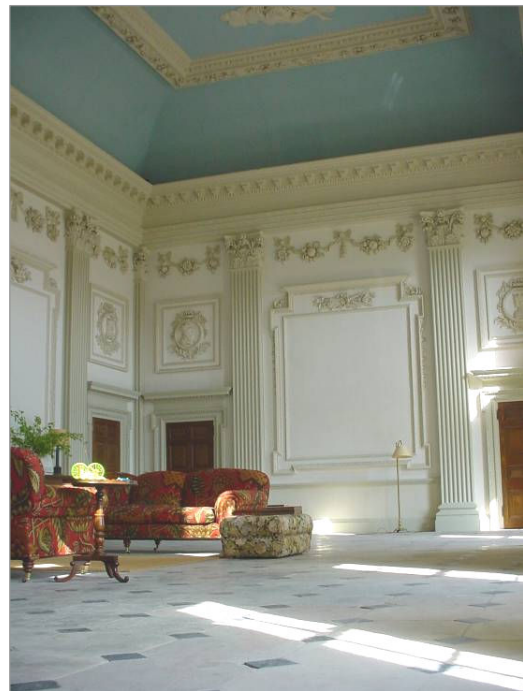
Damage and decay to the roof of this important Herefordshire building had allowed rain to leak into the plasterwork of the Hall.

The conservation of the ceiling required the insertion of a matrix of stainless steel ties, wires and rods which now hold the vaulted ceiling firmly in place. Water damaged plasterwork was removed and replaced with new casts of decorative elements.
